**7th PROJECT (DESWSP) SEMI-ANNUAL ENVIRONMENTAL SAFEGUARDS MONITORING REPORT
FOR THE PERIOD OF JULY –DECEMBER, 2018**

Dhaka Environmentally Sustainable Water Supply Project (DESWSP)

Part A: Distribution Network Improvement (DNI) Package No.: ICB 02.7

Part-B: (Intake, RW Pipeline, WTP, Treated Water Pipeline & Distribution Network)

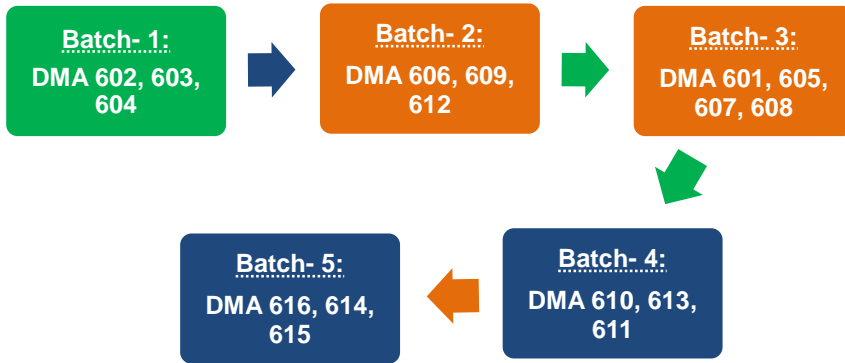
Figure: Flow Diagram of Implementation Plan of ICB 02.7.

27. The pipe installation work is being done in batch system; each batch consists of at least three DMAs. The following flowchart shows the implementation plan of ICB-02.7.

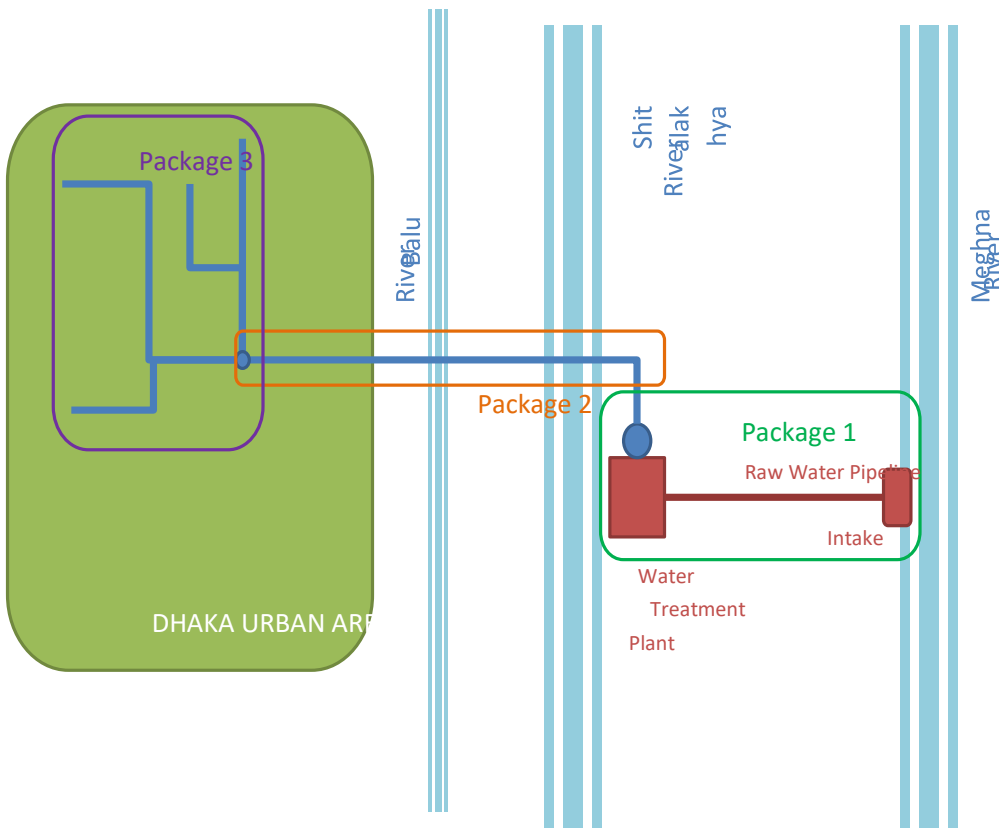
Figure 0.1: Location of the project

The following Figure 0.1 shows the overall scheme of the project with the four project packages.
